IN-TRACK PERFORMANCE OF GEOTEXTILES
AT CALDWELL, TEXAS

Paper for Presentation to

Transportation Research Board Conference
Washington, D.C., January 1986

S. M. Chrismer

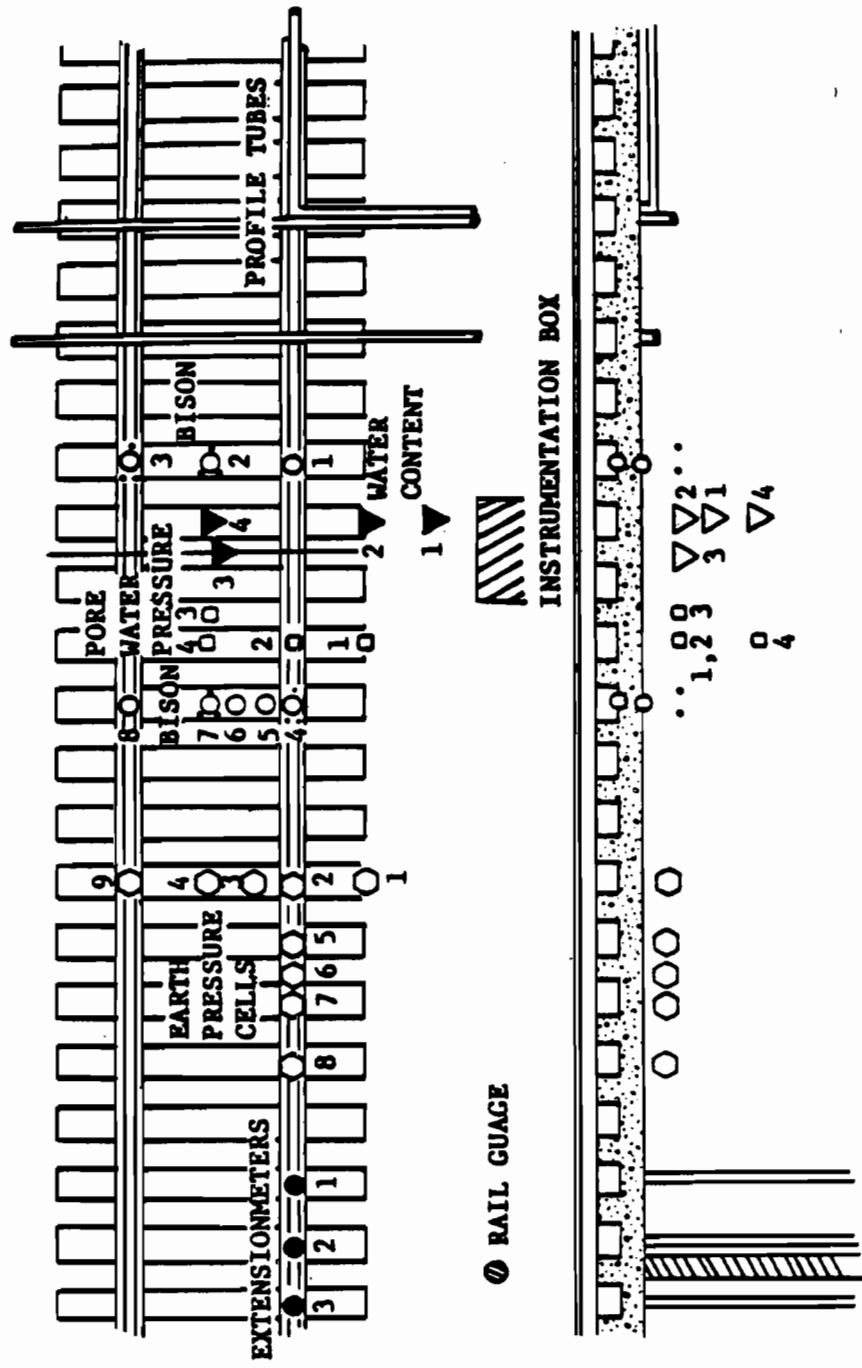
Figure 1. Typical Subgrade Instrumentation

Extensive instrumentation was required in order to differentiate the role that each mechanism played in a given test section. Figure 1 illustrates the subgrade instrumentation that was installed in each section.

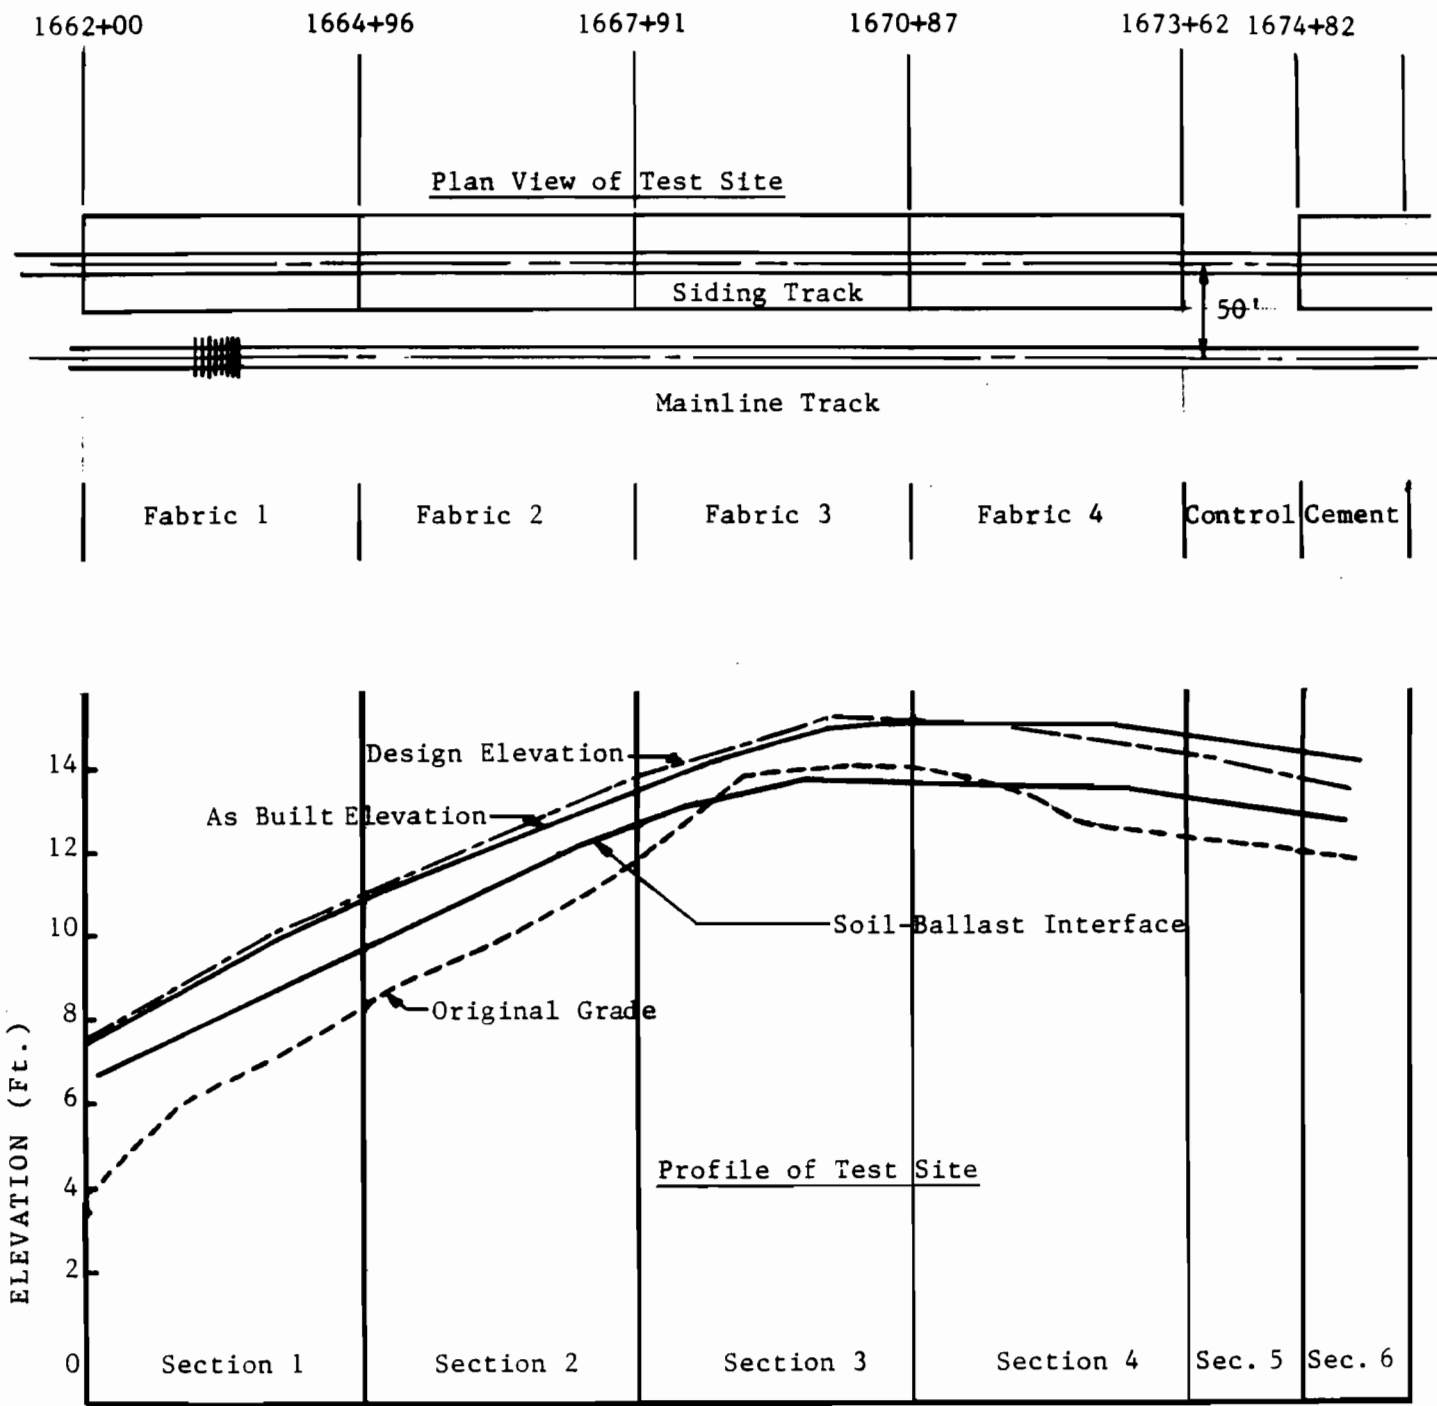
Figure 2 Caldwell Test Site Configuration

The existing and design grades at each of the six individual test sections are shown in Figure 2. Test Sections 1 through 4 were constructed with nonwoven fabrics placed on the subgrade. The properties of the geotextiles are listed in Table 1. Section 5 was a control section with no fabric, and Section 6 was a cement-stabilized zone. Section 6 was used to compare the performance of a conventional, but expensive, method of subgrade stabilization with the performance of the various fabric sections. The length of each of the fabric sections and the cement-stabilized section was 300 feet, whereas the control zone was only 150 feet in length. The control site was made shorter because, it was thought, this track section might fail or experience a large amount of settlement.

Drainage in the test sections was dependent upon the topography and local soil properties. Figure 2 indicates the grade conditions for the overall test site. The steeper grade in Section 1 provided better drainage; however, this section also received runoff from Sections 2 and 3. Thus, various combinations of grade and watershed did not appear to favor any particular section.

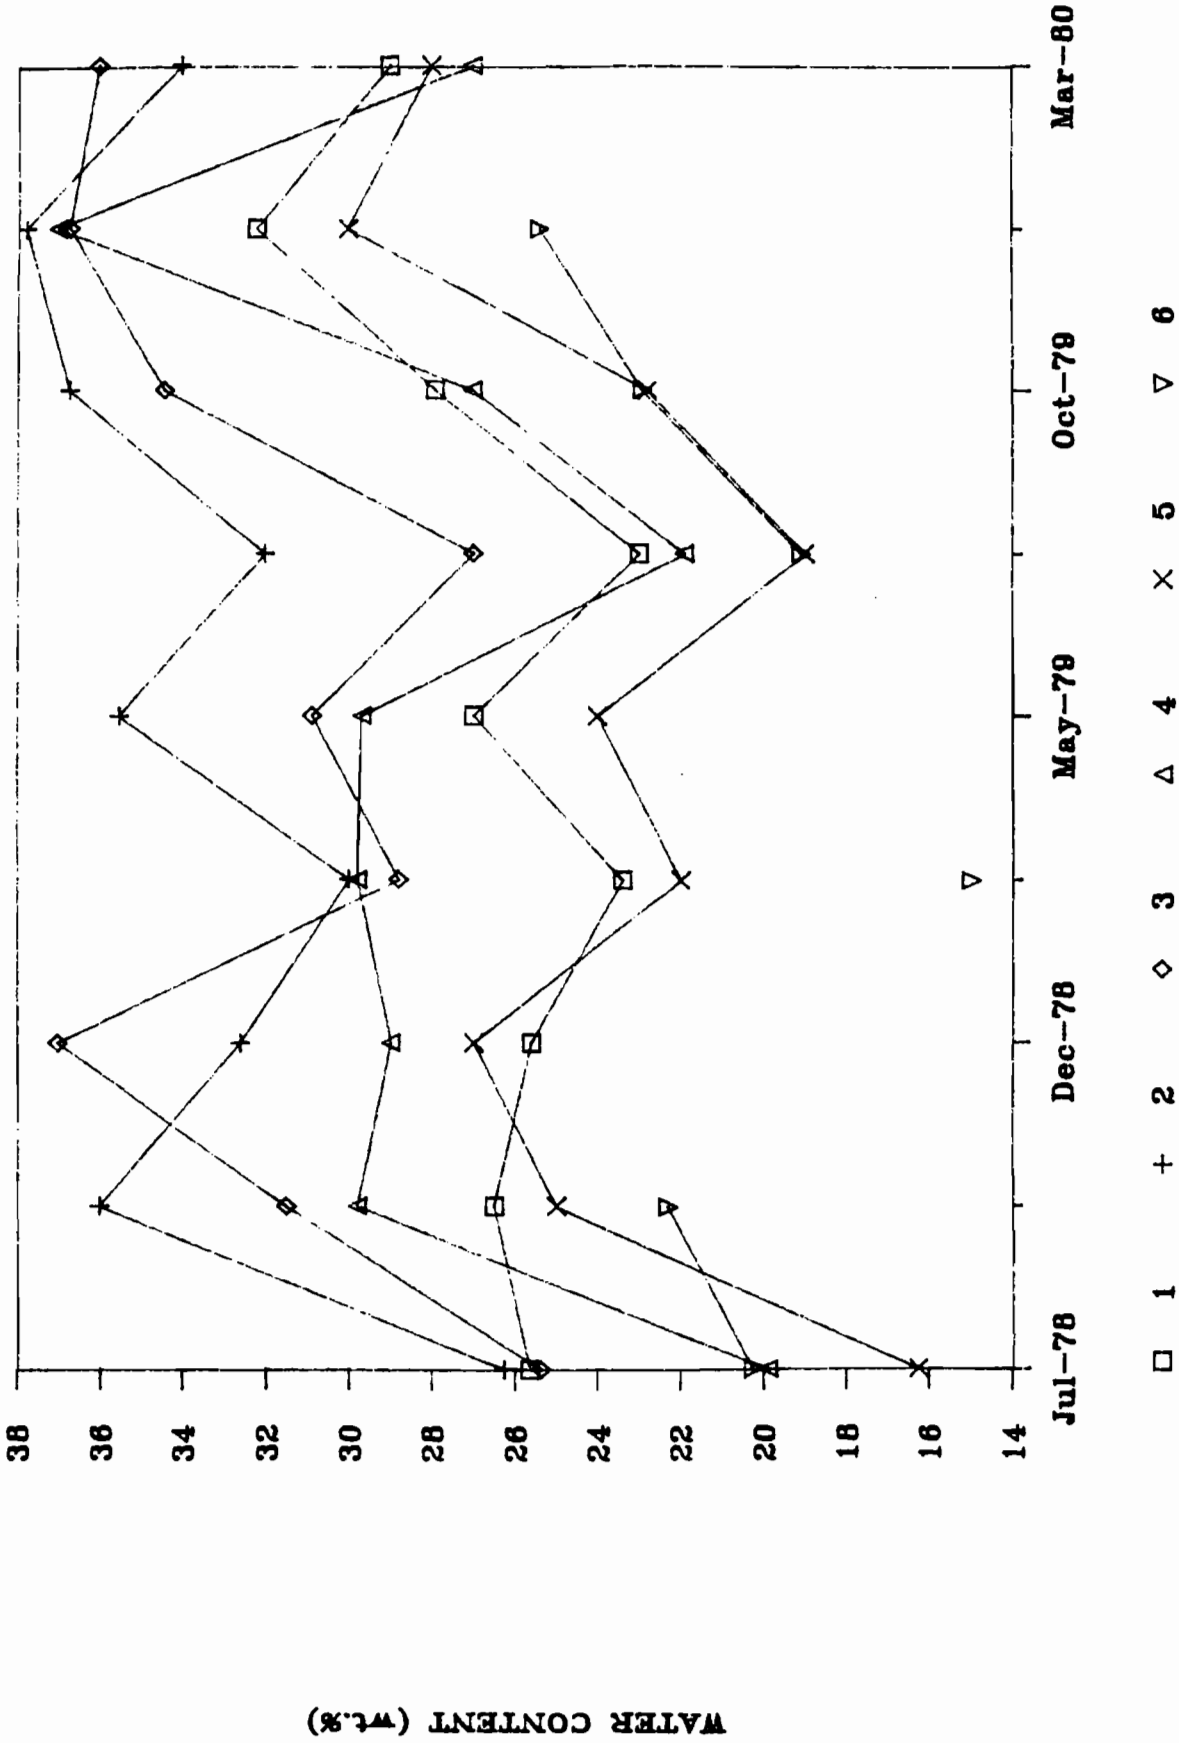
Figure 3. Variations in Average Soil Water Content With Time, in Test Sections 1 - 6

those using instrumentation, gave values of moisture content that were close to those of the field corings. However, the instrumentation responses were more "flat" and did not show the increase due to the rainy months of March through June as did the samples recovered from the field. Because the water content measurements from the manual corings are believed to be the most reliable, only the data from the field corings will be shown. Soil samples were obtained every 6 inches, to a depth of 24 inches, at the middle of each test section. Figure 3 illustrates the variation of subgrade water content in the test sections over approximately one and one-half years. Figure 4 shows the test section differences between the seasonal maximum and minimum soil moistures which occurred during the 17 months.

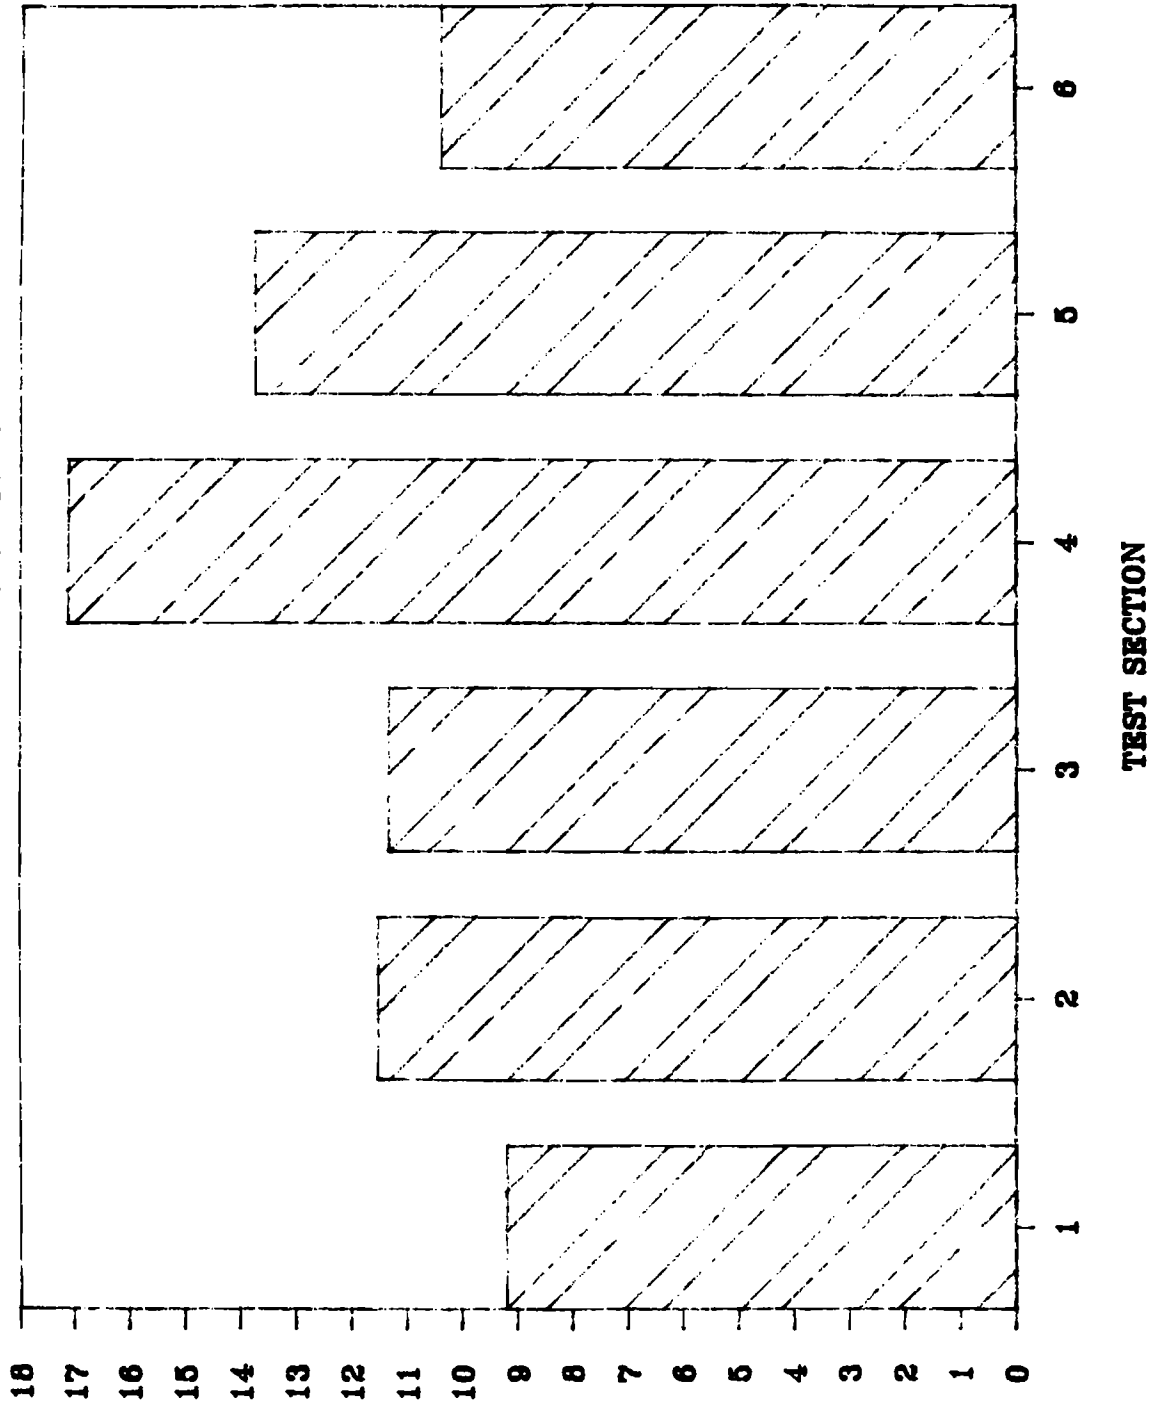
Figure 4. Maximum Seasonal Variations in Soil Moisture Content from July, 1978 to March, 1980, for Test Sections 1 - 6.

Another anticipated benefit of geotextiles, that of moisture transport in the subgrade, could be assessed by the soil moisture measurements and the pore water pressure readings. Although the soil moisture measurements were not consistent between the different measurement methods, there was still enough evidence to conclude that there was no apparent subgrade moisture transport in the fabric sections as compared to the control section. The maximum seasonal variation of subgrade moisture content in Section 5 was not significantly greater than that of the average of all of the fabric sections (see Figure 4).

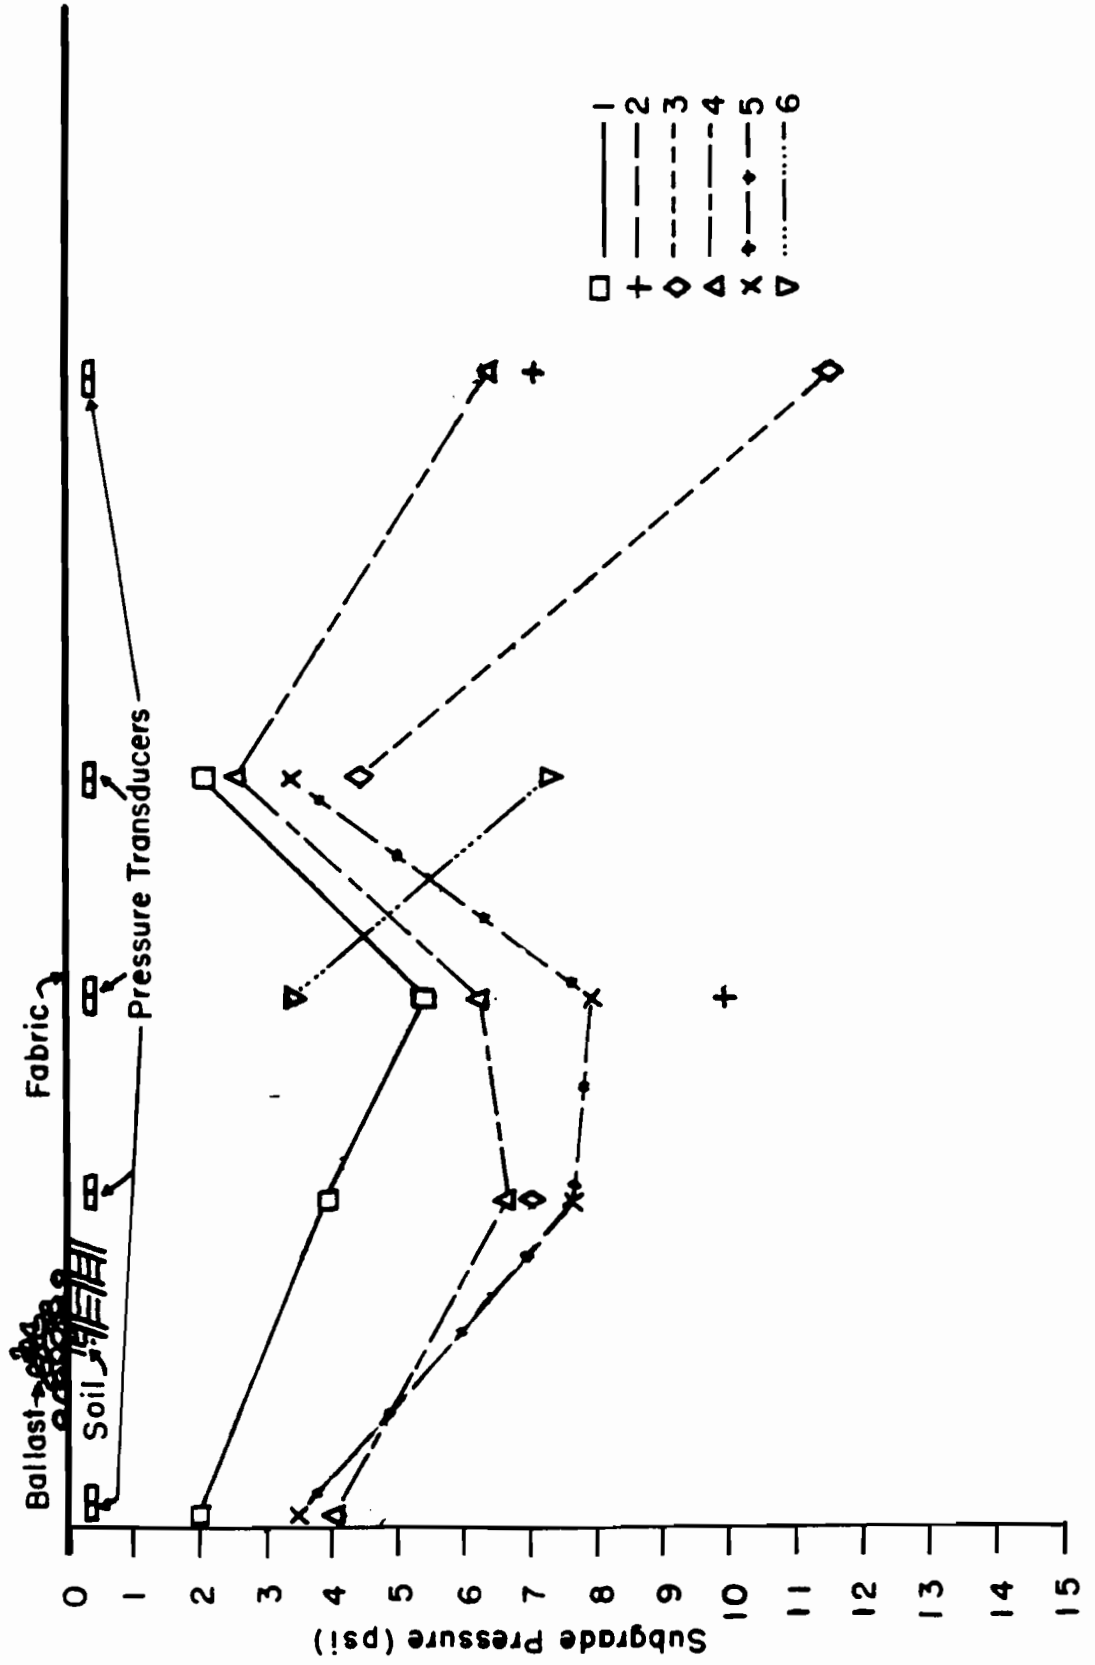
Figure 6. Subgrade Pressures Under One Tie in Each of Test Sections 1 - 6.

The transducers for measuring vertical earth pressures were installed 3-4 inches below the top of the subgrade. Figures 6 and 7 show the transverse and longitudinal layout of the transducers in the soil. The earth pressure measurements shown in these figures were obtained by selecting the maximum pressure registered by each transducer during each locomotive pass. These maximum pressures were generated under the wheel loads of switcher locomotives traveling at velocities ranging from 2 to 50 mph. Because the maximum pressures varied somewhat with locomotive speed (a small variation in most cases and with no definite trend), their average for each of the various speeds was calculated and plotted in Figures 6 and 7.

The transverse and longitudinal earth pressure measurements showed approximately the same pressure profiles for each site. No significant differences could be observed between the pressure profiles observed in the fabric sections and those in the control section. It is interesting to note that the maximum subgrade pressures were measured beneath the cement-stabilized section.

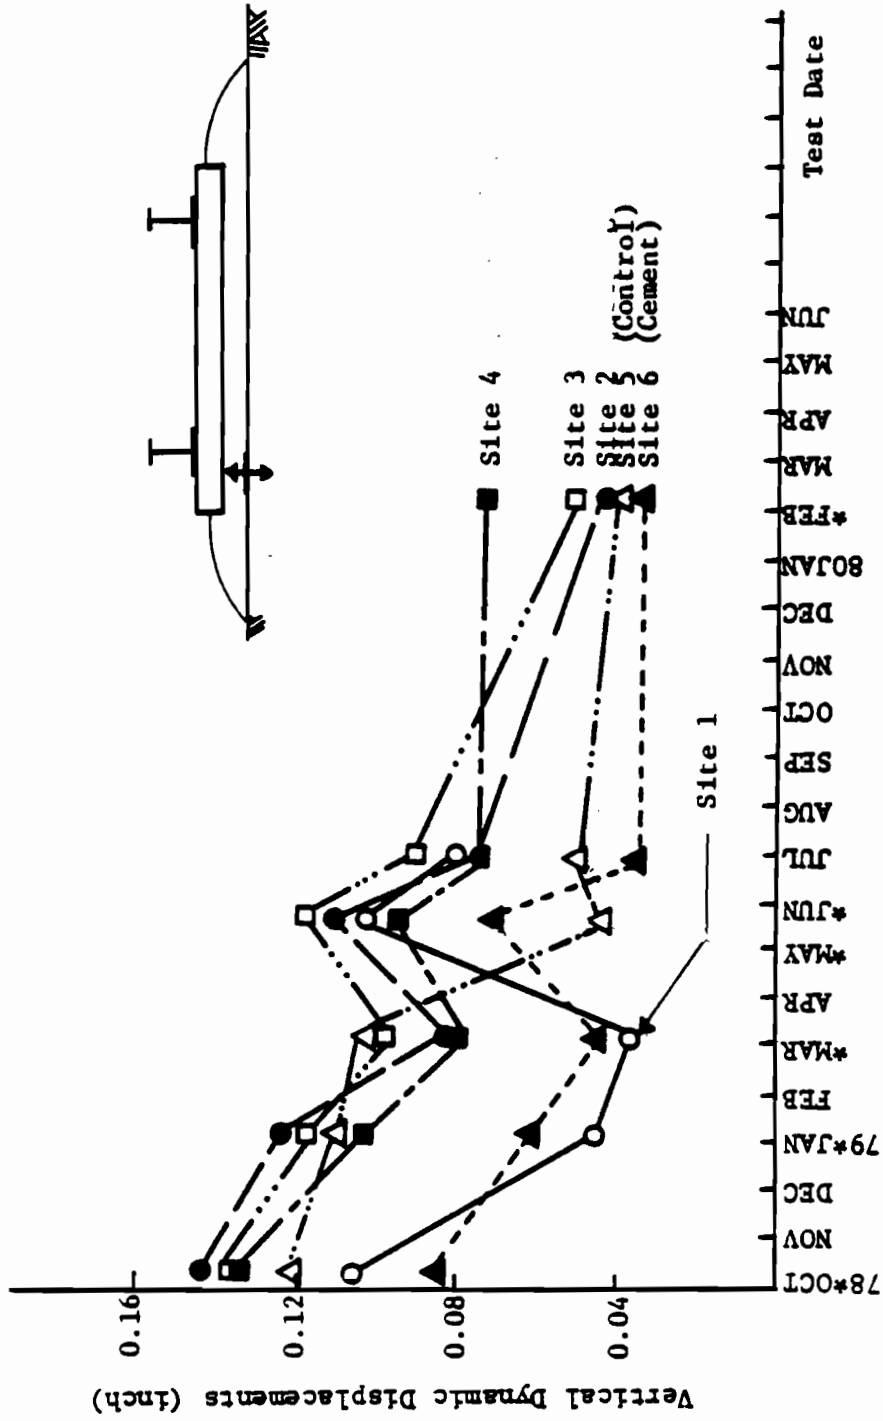
Figure 8. Variations in Mean Values of Elastic Deformation Under Load at the Ballast/Subgrade Interface With Time, for Test sections 1 - 6.

under loading are plotted in Figure 8 for the respective test dates. The elastic deformations measured in Sections 2, 3, 4, and 6 showed the same climatic variations, with Section 6 having consistently smaller amplitudes. General weather data obtained from Caldwell, Texas showed that March through June were months which had significant amounts of rainfall.

The anomalous behavior of Section 5 during the wet season was shown by decreasing elastic deformation, while the other sections were experiencing increasing deformations. Section 1 also had anomalous behavior, as evidenced by the wide range in deformation with the seasons. The soil moisture content data did not indicate that the soil in Section 1 experienced greater variation in of moisture content; in fact, the moisture content in Section 1 was the most uniform during this period.

Because there was no consistent trend in subgrade elastic deformations between test sections, no sections differences are noted. It is interesting that the control section had lower than average elastic subgrade deflections.

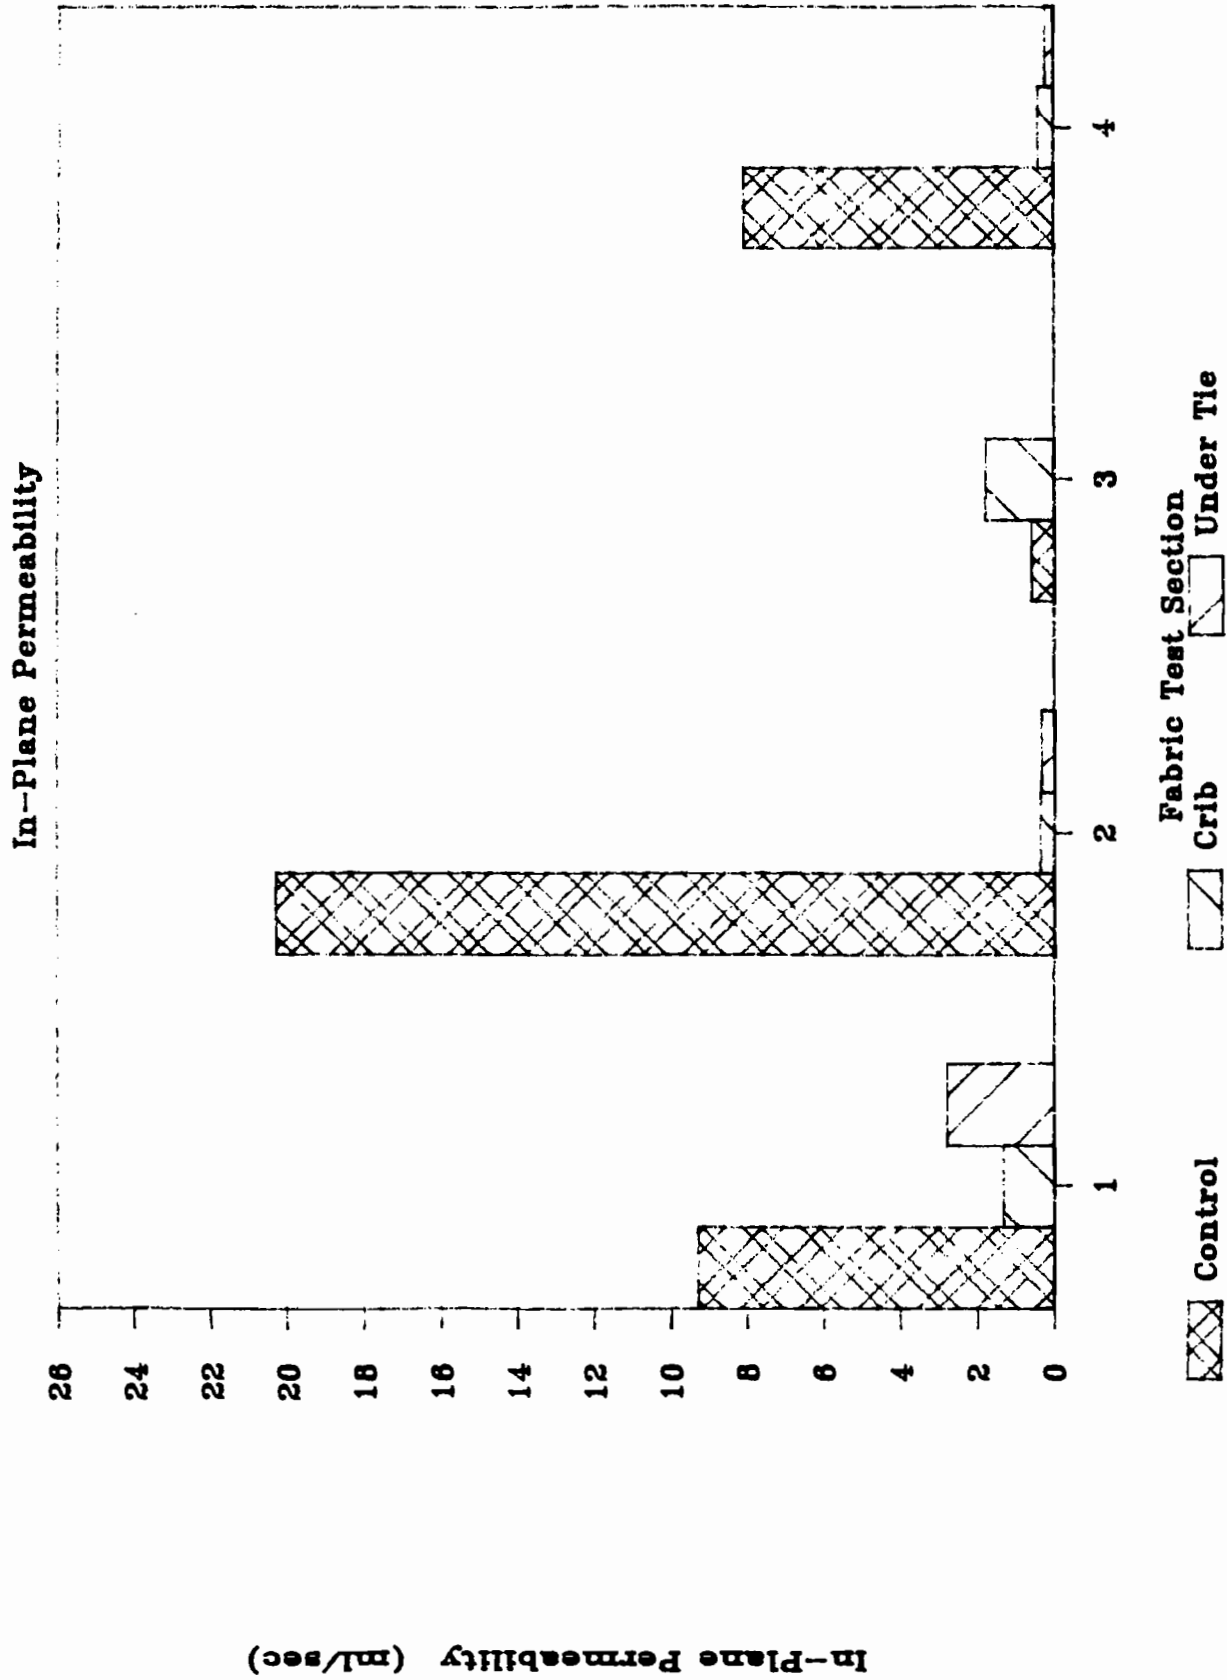
Figure 10. In-Plane Permeability of Geotextiles Recovered From the Field and Tested at a Pressure of 3.4 psi Applied Normal to the Surface.

Figure 10 illustrates the measured decrease in fabric permeabilities when tested in the soiled condition after removal from the field. As shown, the in-plane permeability of the fabric samples after 17 months in track have decreased by as much as a factor of 100. The fabric in Section 1 retained the greatest percentage of its initial in-plane permeability. The test performed on the fabric from Section 3 appeared to show a gain in permeability in the field, however, this test was reported by the technician to be in error. The fabric in Section 3 is known to have clogged more severely in the field than any of the other fabrics.

A combination of visual and microscopic inspections revealed that all of the fabrics had soil particles in the voids of the fibers and on the fabric surfaces. Fabric 1 had the least amount of soil in the fibers, while the other three fabrics had a greater (approximately equal to each other) degree of soil particles in them. These observations confirmed the laboratory permeability results.
