LANDFILL REMEDIATION

GREGORY N. RICHARDSON, PH.D., P.E.  
WESTINGHOUSE - EGS

FIRST U.S. CONFERENCE ON MUNICIPAL SOLID WASTE MANAGEMENT

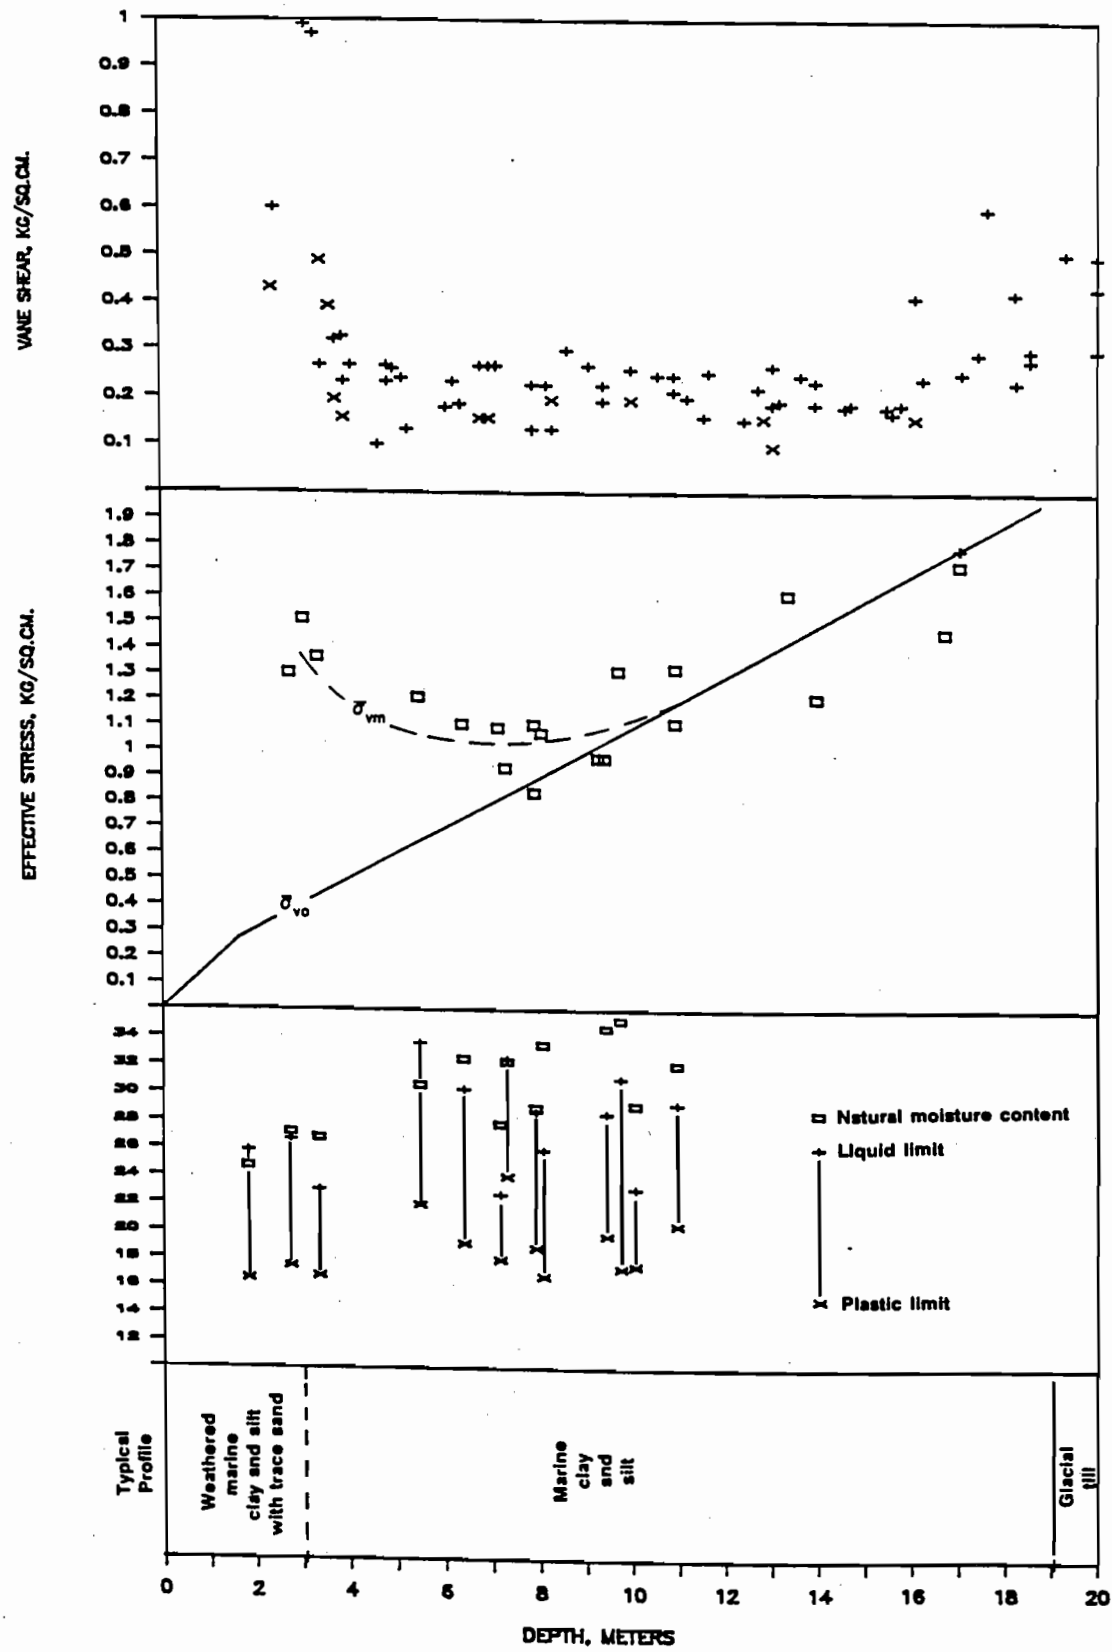
Figure 1 Case 1 Soil Properties Beneath Landfill

While the marine clay and silt offers an ideal natural barrier to the seepage of leachate, the strength of the soil limits the weight of fill which may be placed on top of it. As the landfill expanded, monitoring wells were installed and laboratory tests on soils were run. Some of the monitoring wells included field vane shear tests (ASTM D2573-72) and 76mm Shelby tube sampling. Laboratory testing included classification, strength, and consolidation testing. Figure 1 shows typical laboratory Atterberg and consolidation test data, as well as vane shear data, for the marine clays and silts.

reasonable value for the density of the landfill, a height limitation of 17 meters was placed on the existing MSW landfill in mid-1986. With fill above that level, it was calculated that the factor of safety against a slope failure would be below 1.25 for short term conditions and that was not acceptable. Laboratory testing subsequent to the landslide and back-calculations from the slide itself have shown that the field vane test values were in fact considerably lower than the shear strengths developed in the clay-silt.

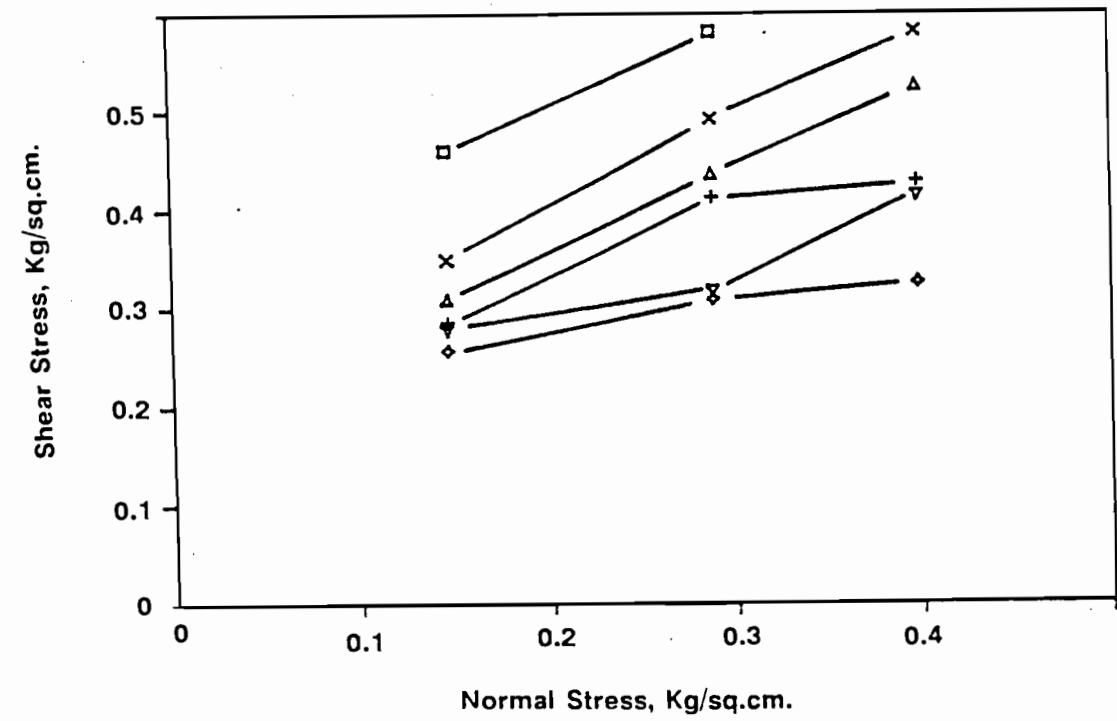
Figure 2 - MSW Direct Shear Test Results

To measure the shear strength of the trash, the owner constructed a 1.5m<sup>2</sup> square shear box. The box was loaded with large concrete blocks to vary the normal force in the test. Figure 2 provided a summary of the results.

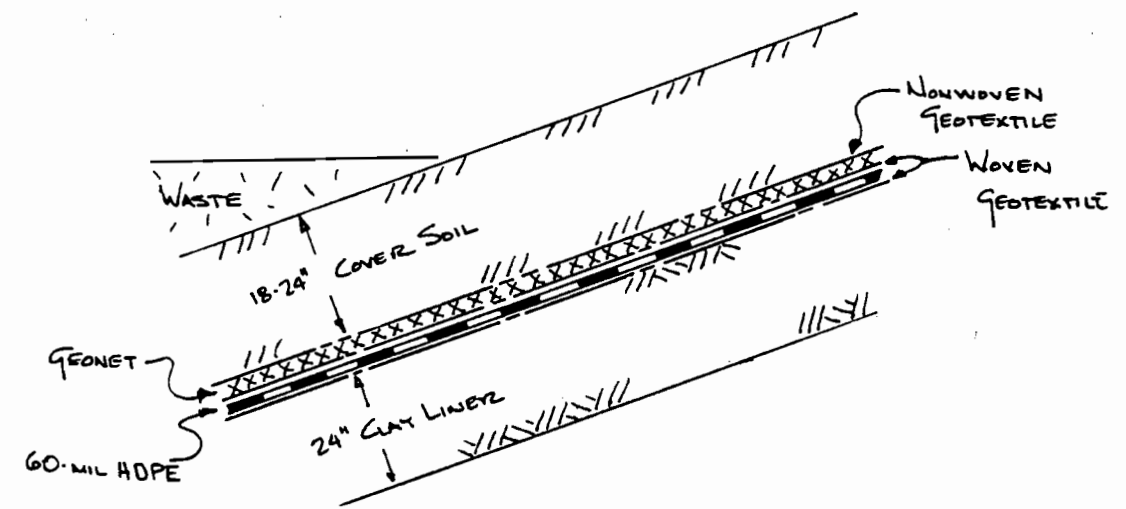
Figure 3 Failed CERCLA Liner System - Case 2

During the construction of an industrial landfill in Ohio, a layer of cover soil being placed over the synthetic liner collapsed. This collapse resulted in much of the synthetic liner being dragged to the base of the sideslope. The design profile of the sidewall liner system is shown on Figure 3. As is commonly the case, the sidewall liner system was the product of both state regulatory demands and the designers original intent. Interestingly, the failure occurred between the HDPE liner and the lower slit-film woven geotextile.

Post failure laboratory testing indicated that the coefficient of friction between the HDPE liner and the slit-film woven geotextile was approximately 9-degrees. This confirmed that the weight of the cover soil was carried by tension in the upper geotextile and the liner, by the frictional components between the layers, and by the compressive strength of the cover layer itself. An analysis was performed to estimate the minimum cover soil cohesion required to maintain a minimum factor-of-safety against sliding of 1.0. Figure 4 shows the results of this analysis and the range of cohesion values actually obtained from samples of the cover soil. The cause of the failure became evident when field surveys indicated that slope lengths exceeded 120-feet.

Remediation of the sideslopes involved replacement of the smooth HDPE liner with textured HDPE, and the use of nonwoven geotextiles. Both measures dramatically increased the interface friction angles between the geotextiles and the liner. This successfully reduced the load being carried within the plane of the cover soil. Additionally, note that the geonet drainage layer was bonded to the geotextiles bounding it. This was necessary to prevent placing the geonet in tension.

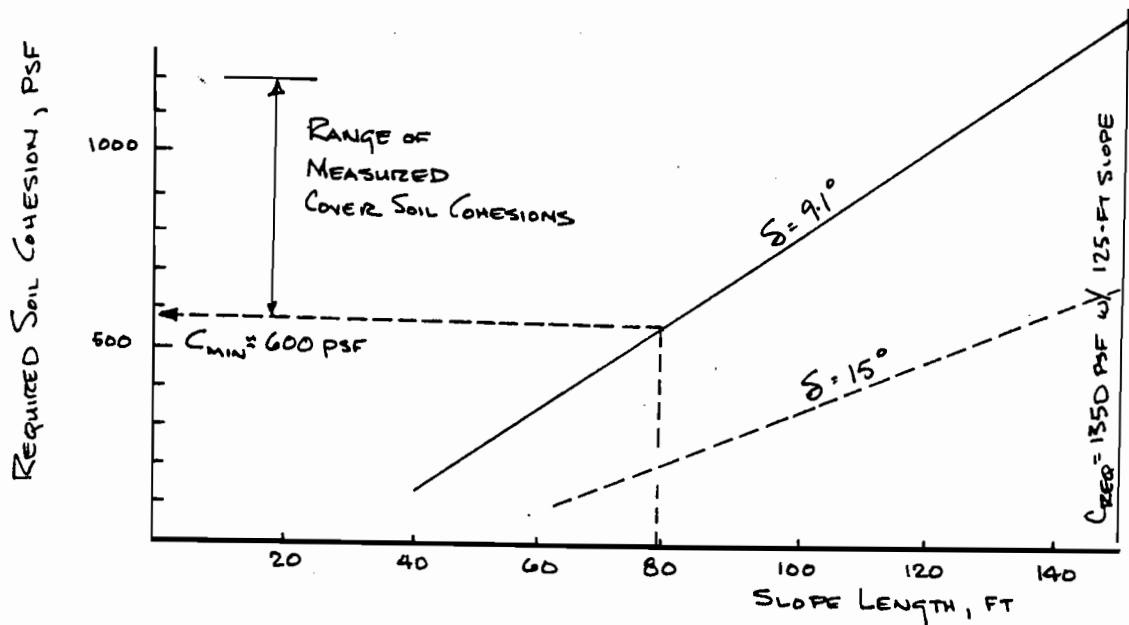
Figure 4 Cover Soil Shear Strength vs Stable Slope Length - Case 2

Just such a failure had concerned the design engineer. Early calculations indicated that the cover soil would be marginally stable if the slope length was less than 79 feet. To provide a greater margin of safety, the designer required that no more than 15 feet of cover soil be placed in advance of the waste.

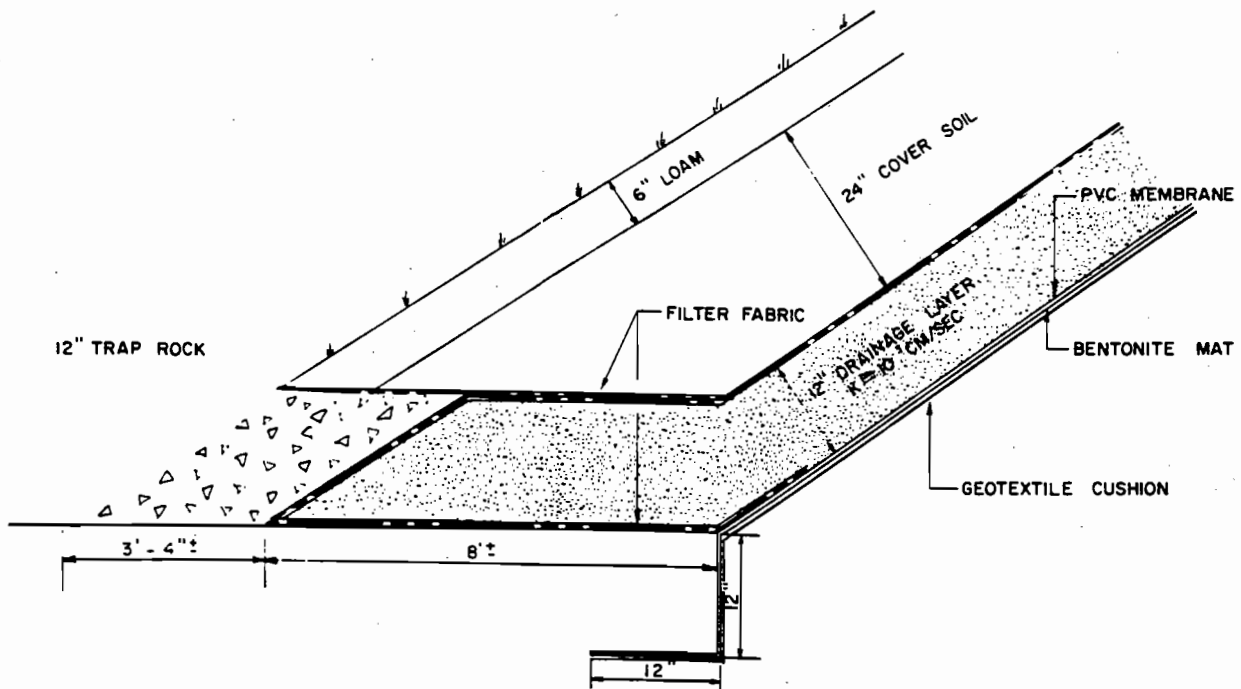
Figure 5 Initial CERCLA Cover System - Case 3

The design profile for this cover and the slope toe drainage detail are shown on Figure 5.

The low-permeability barrier was an effective composite formed by the 30-mil PVC geomembrane and the bentonite mat. However, the bentonite mat has an upper surface composed of a woven polypropylene geotextile. As in the previous case study, the coefficient of friction between a geotextile and a smooth geomembrane typically ranges from 9-12 degrees. Thus the cap profile constructed on the design 3H:1V slopes would either be unstable or would rely on the tensile strength of the filter fabric and the geomembrane.

While no failure occurred in this cap, the success was due to the small size of the cap and not to the technical ability of the designer. No stability calculations had been performed and no geogrid installation guidelines were prepared. Interestingly, the EPA review process did not detect these omissions.

Just prior to letting bid documents, a geogrid was added to the cover profile. The geogrid was placed immediately above the filter fabric and was intended to carry the weight of the
