Survivability of Subgrade Separators

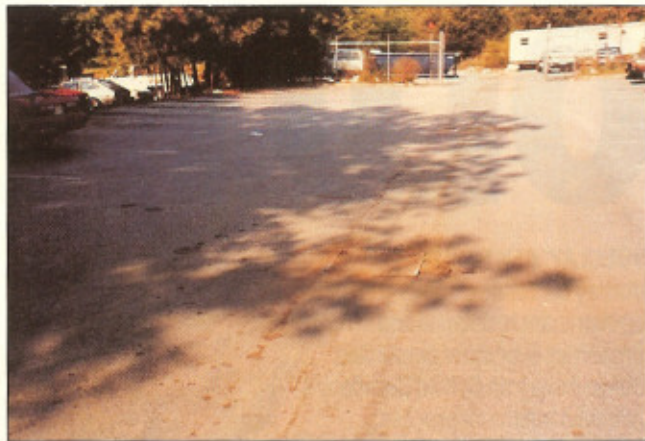
Figure 3: The square cut in the asphalt (center of photograph) corresponds to section B of Figure 1. The left and right sides of the lots correspond to Section A of Figure 1.

Figure 3 is an overview of the parking area. The square cut in the asphalt can be seen in the center of the photograph. The center of the lot corresponds to

Section B of Figure 1. The left and right sides of the lots correspond to Section A of Figure 1. The entire parking area is in excellent condition. There are no large cracks, buckling, or potholes anywhere in the lot.

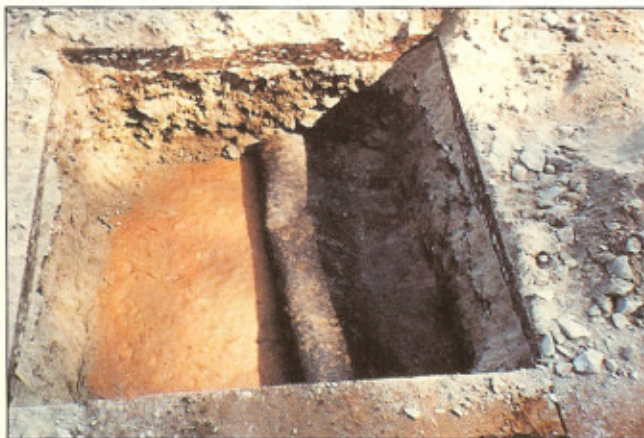
Figure 4: A slit tape woven fabric was exhumed from location 2. Subgrade pumping did not occur, and the fabric showed no signs of damage.

Figure 4 shows a slit tape woven fabric being exhumed from Location 2. The pavement structure is in

excellent condition. Subgrade pumping has not occurred, and the fabric shows no signs of damage. Figure 5 shows the same sample on a backlighting inspection table. There are no signs of holes, tears, or other imperfections that would lead to any loss in hydraulic properties.

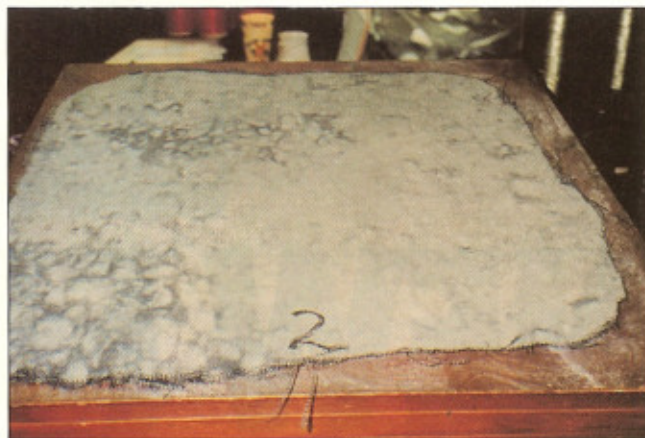
Figure 5: The slit tape woven sample on a backlighting inspection table. There are no signs of imperfections that would lead to any loss in hydraulic properties.

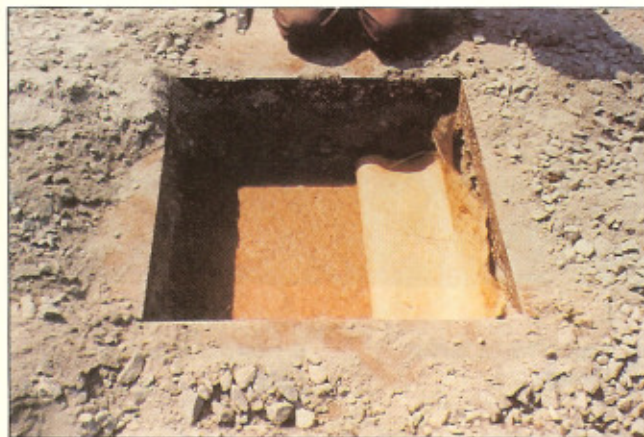
Figure 6: Slit tape woven fabric being exhumed from location 3.

woven fabric being exhumed from Location 3. Again, the fabric is in excellent condition as shown in Figure 7. There was no evidence of subgrade pumping at this location.

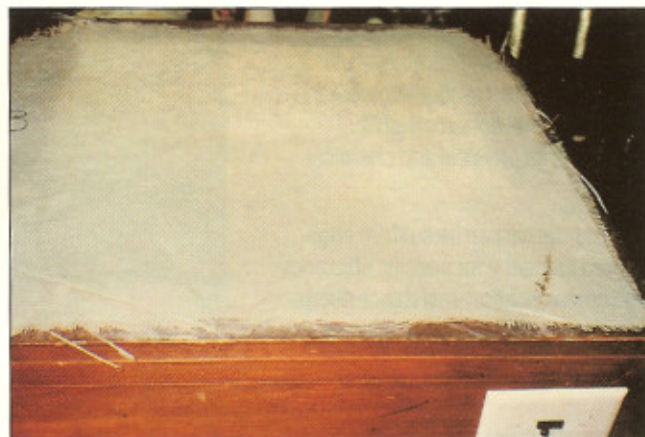
Figure 7: There was no evidence of subgrade pumping at this location.

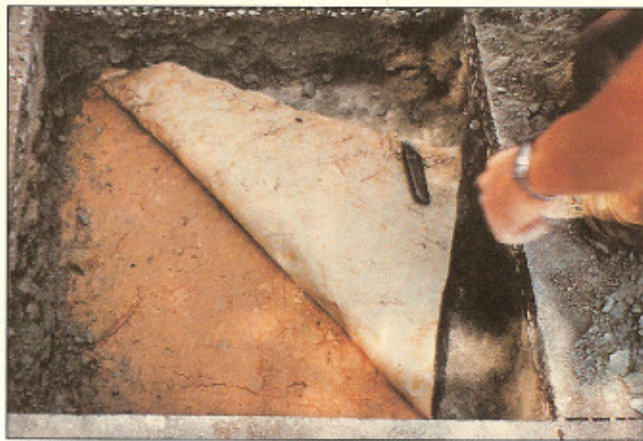
Figure 8: Exhuming spunbonded nonwoven fabric at location 5. Both the fabric and pavement structure were in excellent condition.

Figures 8–11 show non-woven fabric samples from locations 5 and 7. An overlap was encountered at location 7, but there was no apparent performance problem caused by the overlap. As in

the previous locations, both the fabrics and the pavement structures were in excellent condition.

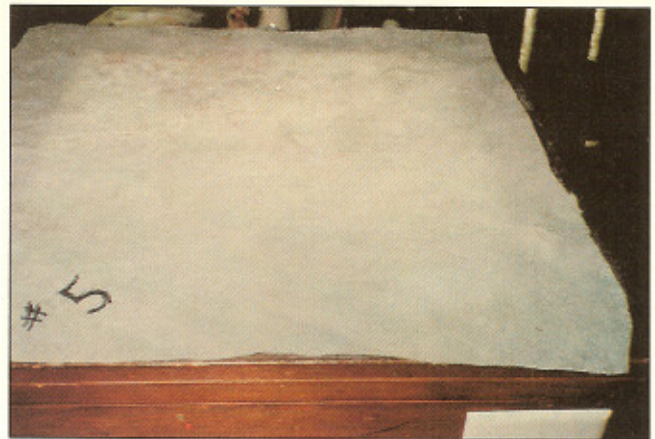
Figure 9: Nonwoven fabric samples from location 5 showed no problems.

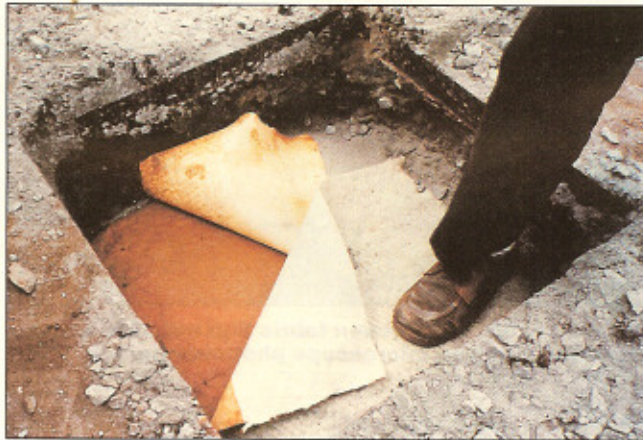
Figure 10: Exhuming needle-punched nonwoven fabric encountered an overlap at location 7, but no performance problems.

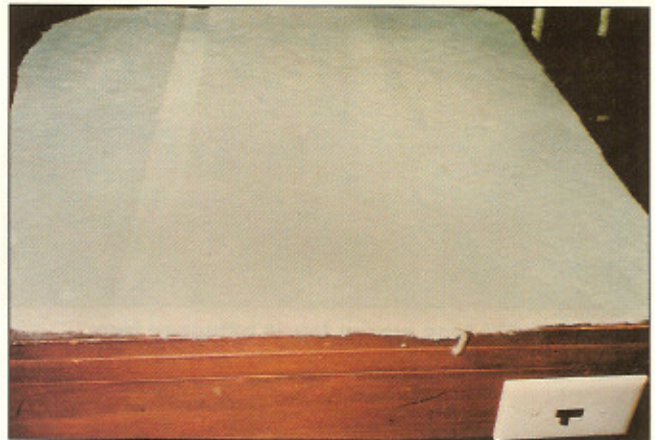
Figure 11: Needle-punched nonwoven fabric (exhumed from location 7) on a light table.

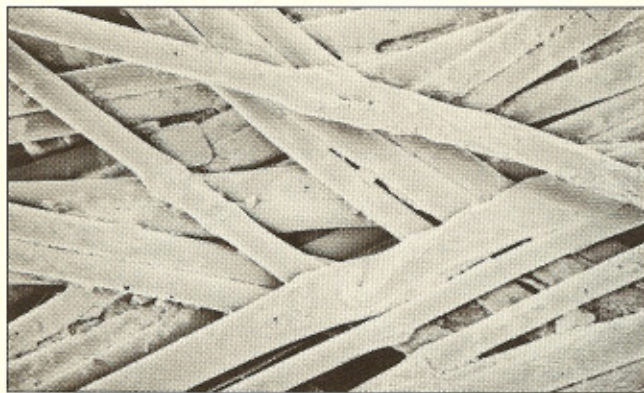
Figure 12: A scanned electron photomicrograph of exhumed spunbonded nonwoven fabric from location 5.

The nonwoven fabrics are also in good condition as shown by the photographs. Some crushing of the fibers has occurred in the fabric in Location 5, but no failure of the system is shown.

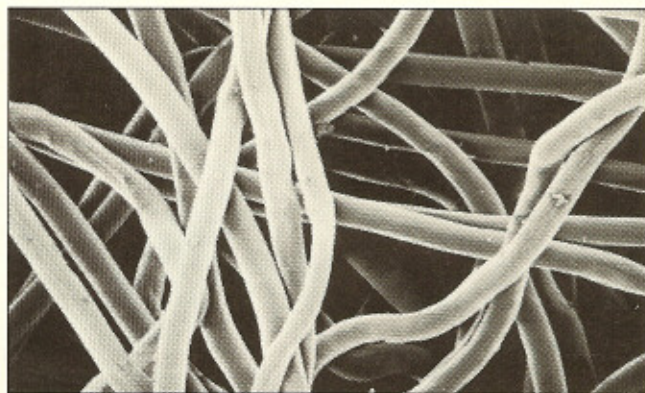
Figure 13: Needle-punched nonwoven fabric from location 7.

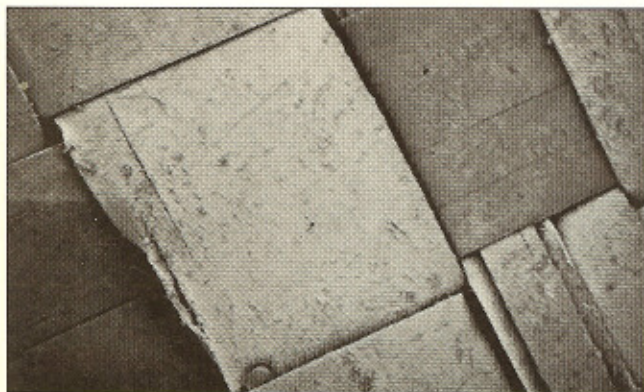
Figure 14: Slit tape woven fabric exhumed from location 3.

The photomicrographs of the woven fabrics show some cracking and splitting of yarns, but no complete failure of the yarn systems is indicated. Also, no punctures or yarn movements which would lead to a degradation of hydraulic properties is indicated by the photographs.

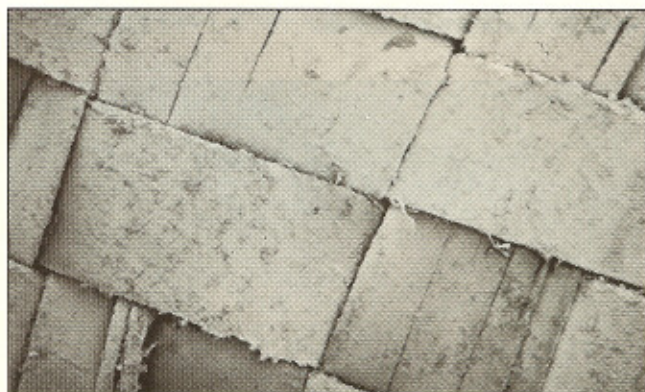
Figure 15: Slit tape woven fabric illustrated in a scanned electron microscope photomicrograph.
