LESSONS LEARNED FROM THE FAILURE OF A GEOTEXTILE REINFORCED RETAINING WALL FACING

by G.N. Richardson

KEYWORDS: Geotextile, Retaining Wall, Failure, Wall Facing, Field Observations

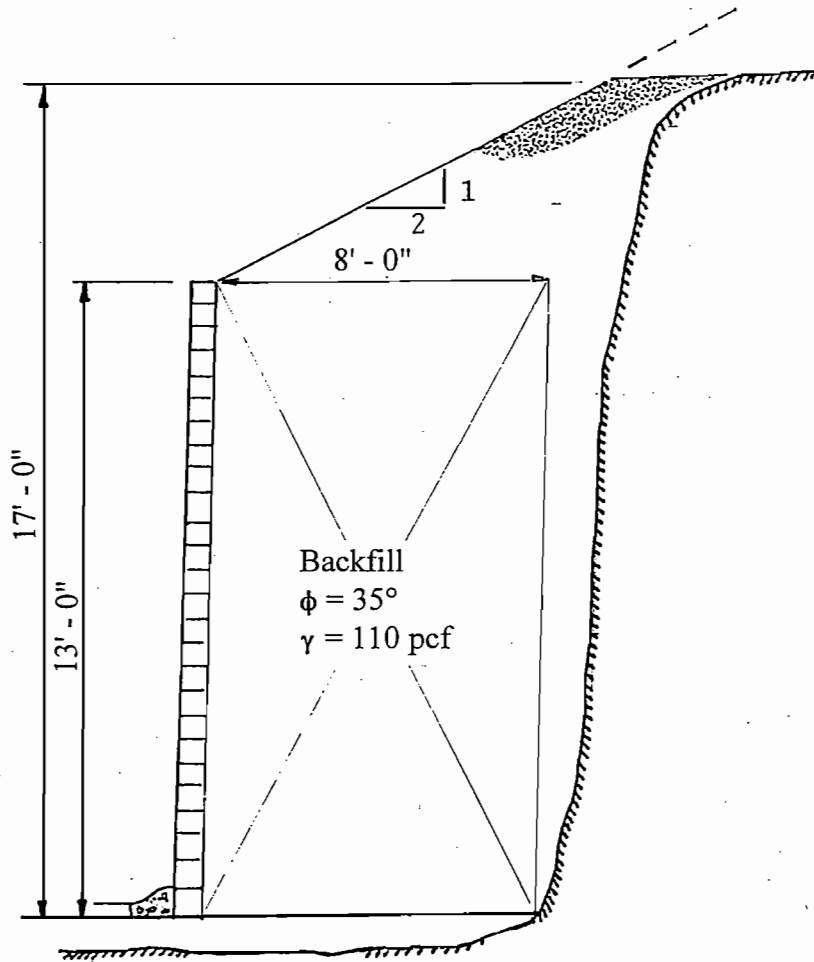
Figure 1 Maximum Design Wall Section

In the fall of 1987, Soil & Material Engineers was providing general geotechnical services for the construction of a small retail center being constructed in Raleigh, North Carolina. It had become obvious during the planning of this center that vehicle access to the rear of the center would be very limited. To ease access, the Raleigh office of Soil & Material Engineers was asked to design a retaining wall for the northern property line. The required wall would have a maximum height of 13 feet and a length exceeding 340 feet. The restricted space at the site limited the depth of the reinforced zone to less than 8 feet. This resulted in a wall aspect ratio (reinforcement length/wall height) of 0.60. The details of the wall geometry at maximum height are shown on Figure 1.

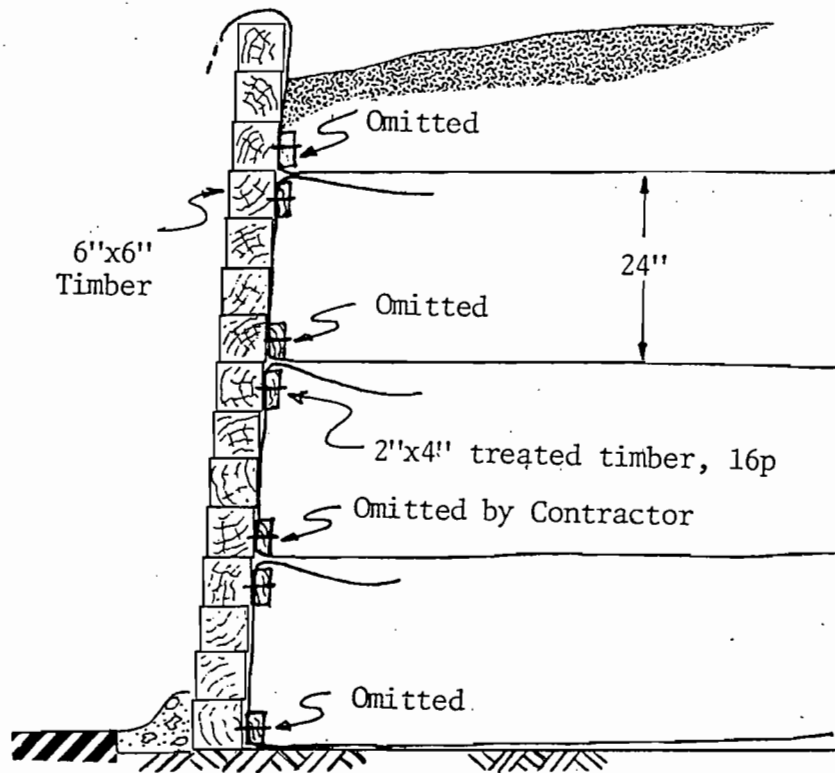
Figure 2 Initial Wall Section - Reinforcement and Connection

The initial construction of the wall was begun in the fall of 1987. The timber facing was to be attached to the wrapped faced geotextile wall using the detail shown on Figure 2. The geotextile reinforcement was vertically spaced approximately the height of four 6x6 facing timbers or approximately 24 inches. A single treated timber 2x4 was nailed from behind the geotextile into the timber facing at the top of each backfill lift. The lower 2x4 at each lift had been omitted by the contractor. Post-failure inspection showed that 16 penny nails were used at approximately 30 inch spacing to secure the 2x2 attaching the facing.

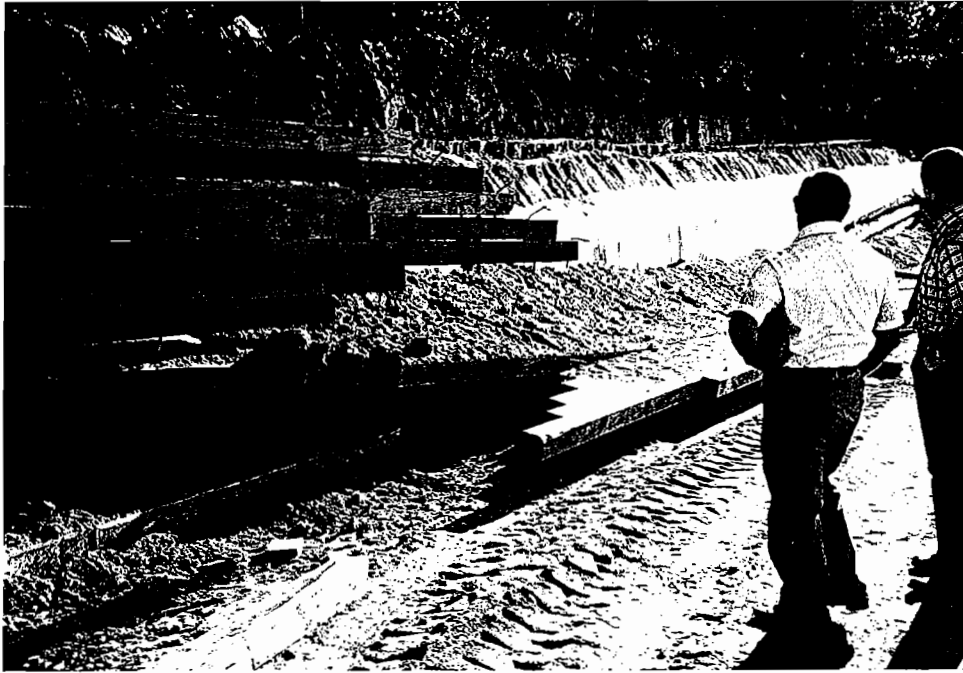
Figure 3 Collapse of Facing - Original Wall

As the final soil surcharge was being placed atop the wall, a significant bulge developed in the facing. Workers were cleared from the vicinity of the wall and a cursory inspection made that same day. The following morning the timber facing of the wall was found nearly completely collapsed and lying on the ground in front of the geotextile wall, Figure 3. The geotextile wall itself was stable and not damaged by the collapse of the facing.

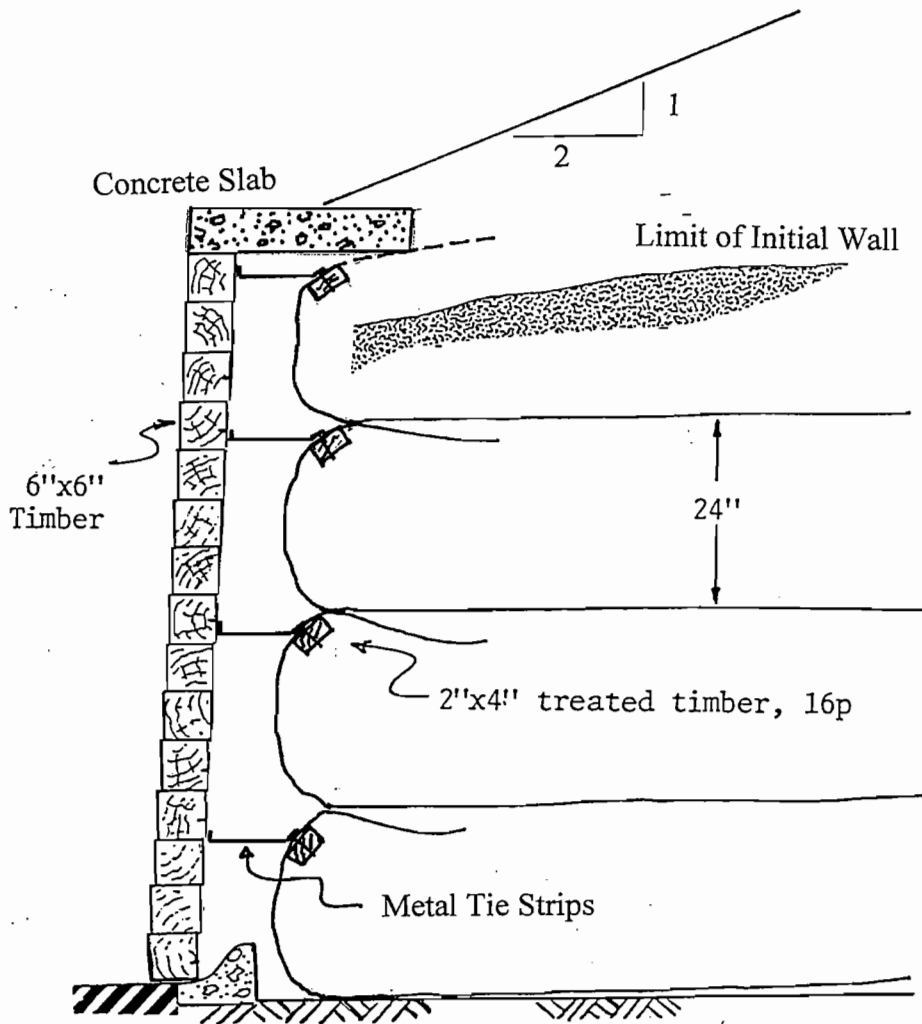
Figure 5 Free Standing Wall Facing

The timber facing was reconstructed 12 inches from the geotextile wall and attached to it by means of metal strips as shown on Figure 7. These strips were secured to the back of the timber facing and the existing 2x4 strip behind the geotextile face with galvanized 16 penny nails. Note that the space between the timber facing was intended to be left empty. The author does not know how the metal strips were designed.
