Designer's Forum- Beneath the bubble: industrial lagoon closure

By Gregory N. Richardson, Ph.D. P.E., Stacey A. Smith, P.E., and Timothy F. Carr, L.E.P.

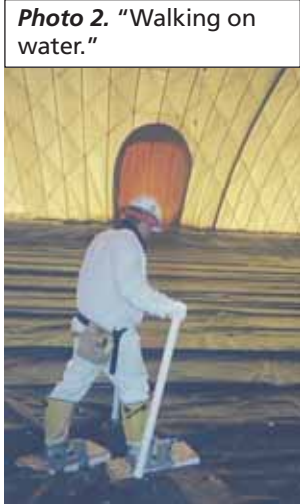
Photo 2 shows the completed geosynthetic system in place beneath the bubble. This photo is generally referred to as “walking on water.” Each layer was fabricated outside of the bubble, rolled up and passed through a modified airlock portal and then unrolled for final deployment.

Photo 2. “Walking on water.”

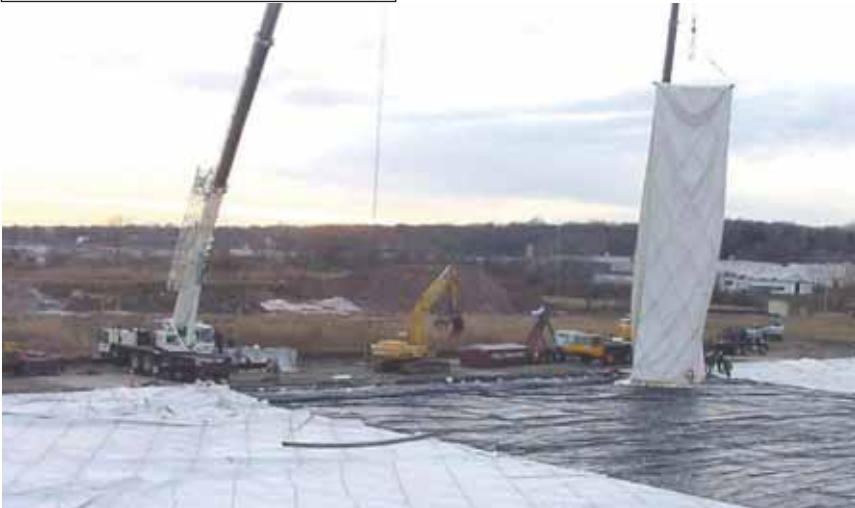
Photo 3. Removal of the bubble.

The rate that water could be removed from beneath the geomembrane was limited by the capacity of a newly constructed wastewater treatment facility to receive it. Initial loading of the geomembrane was accomplished using only clean water to surcharge the geomembrane. While producing only a limited increase in the strength of the underlying sludge, completion of this phase allowed removal of the bubble shown in **Photo 3**. Prior to removal of the bubble, Styrofoam sheets were floated over the pond to further protect the geomembrane from potential damage from the steel cabling used to secure the bubble. Bringing the bubble down took less than 10 uneventful minutes due to these precautions

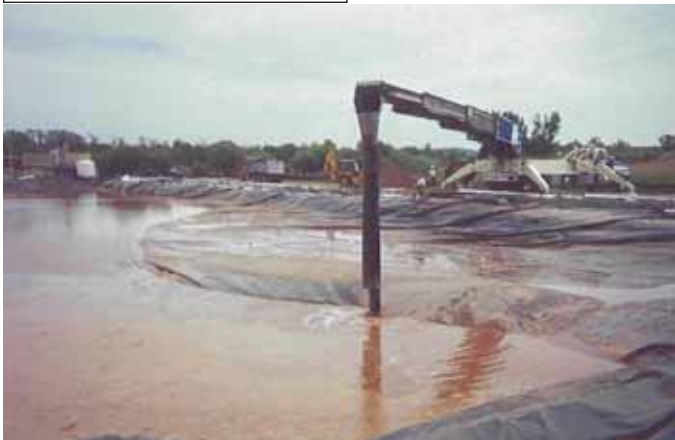
The revised soil placement technique centered around a unique conveyor truck originally designed for placement of rip-rap. As shown in **Photo 4**, the conveyor truck (Telebelt) allowed pinpoint placement of soil without the need for equipment directly on the geosynthetics. The Telebelt could place up to 1500 cubic yards of fill in an eight hour shift and enabled all bulges to be loaded and flattened. The rate of fill placement was limited by the rate of treatment of the new wastewater plant and not the Telebelt. The Telebelt was used to place approximately 5 ft. of cover over the geosynthetics. After this placement, conventional means could again be used to place the fill.

Photo 4. Placement of soil.

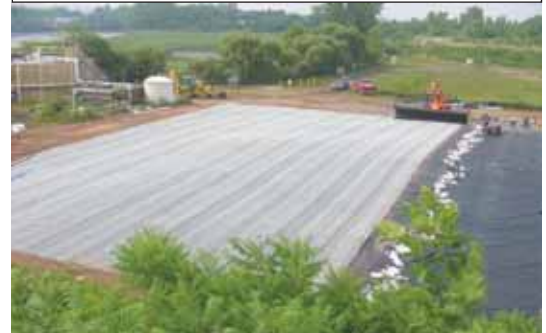
Photo 5 shows the construction of the final cover moving west to east. The soil was graded to provide a typical slope of 3% to the perimeter. **Photo 6** shows the completed final cover over the lagoon.

Photo 5. Geomembrane installation.

Once the majority of primary consolidation was finished in the sludge, the fill was regraded to final cover contours. The RCRA final cover consisted of the following from bottom up:

- reinforced geosynthetic clay liner (GCL)
- 60-mil HDPE geomembrane
- geosynthetic drainage composite
- 28-in. of sandy vegetative support soil
- 6-in. of topsoil with grass cover.

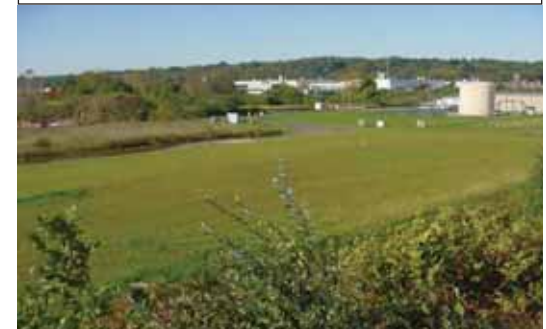
Photo 6. Completed final cover.
