Survivability of Subgrade Separators

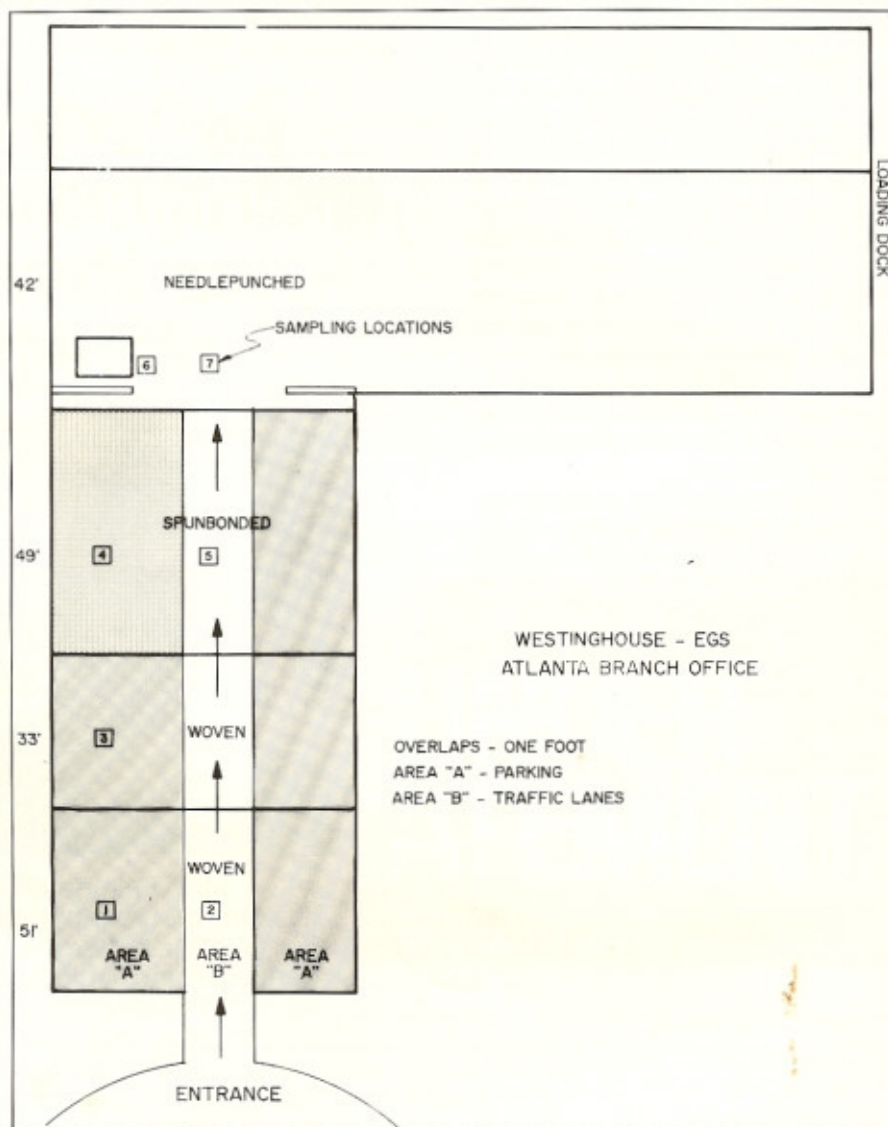
The fabrics cover two distinctly different traffic zones as shown in Figure 1. Area A was used primarily for parking, while area B was subjected to traffic consisting of delivery trucks, various construction vehicles, lowboys carrying drill rigs, and client and employee automobile traffic.

Figure 1: The fabrics cover two distinctly different traffic zones. Area A was used primarily for parking. Area B was subjected to traffic consisting of delivery trucks, various construction vehicles, lowboys carrying drill rigs and automobile traffic.

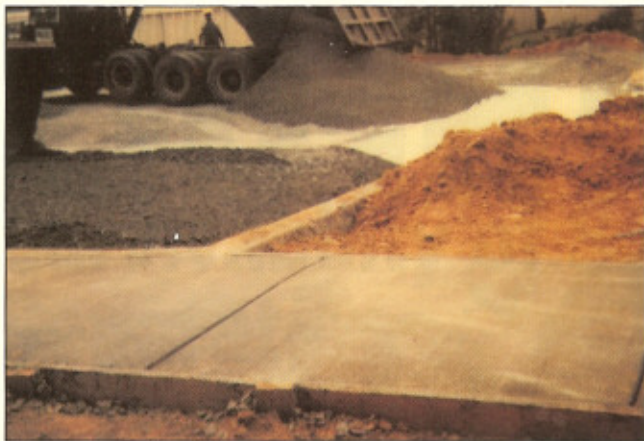
lot paving included eight inches of crusher run gravel and two inches of bituminous pavement. During construction, all gravel was placed by dumping onto previously placed gravel, Figure 2, and then spread by rubber-tired equipment. Thus the geotextiles were not subject to direct impact loads nor tracked equipment.

Figure 2: During construction all gravel was placed by dumping unto previously placed gravel.
